Manhole Inspection Summary

Manhole # S25C__016MH

Insp Date: **8/2/07 9:36 AM**

Location Address: **329 CAREY ST**

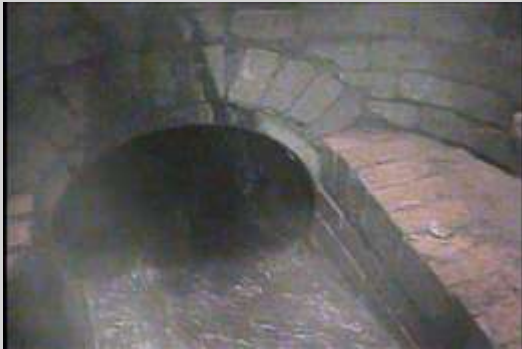
12 O'Clock Outflow

21 in. Circular Gravity Sewer
Pipe Out @ 12 O'Clock

Pipe Height: **20.4** (in.) Rod and Bar (Angled)
Pipe Material: **Clay** ☐ Pipe Lined
Invert Depth: **19.62** (ft.) Flow Characteristics: **Fast**
Deposits: ☒ None ☐ Mud ☐ Sludge ☐ Debris ☐ Grease
Silt Depth: (in.) Deposits Extent:
Infiltration: **None** Pipe Seal Cond: **Sound**
